AL SHURHABIL SCHOOL
UNDER THE COMMANDER'S EMERGENCY RESPONSE PROGRAM
ANBAR PROVINCE, IRAQ

SUSTAINMENT ASSESSMENT

SIGIR PA-08-142
JANUARY 21, 2009

SUBJECT: Report on Refurbishment of the Al Shurhabil School in Anbar Province, Iraq
(Report Number SIGIR PA-08-142)

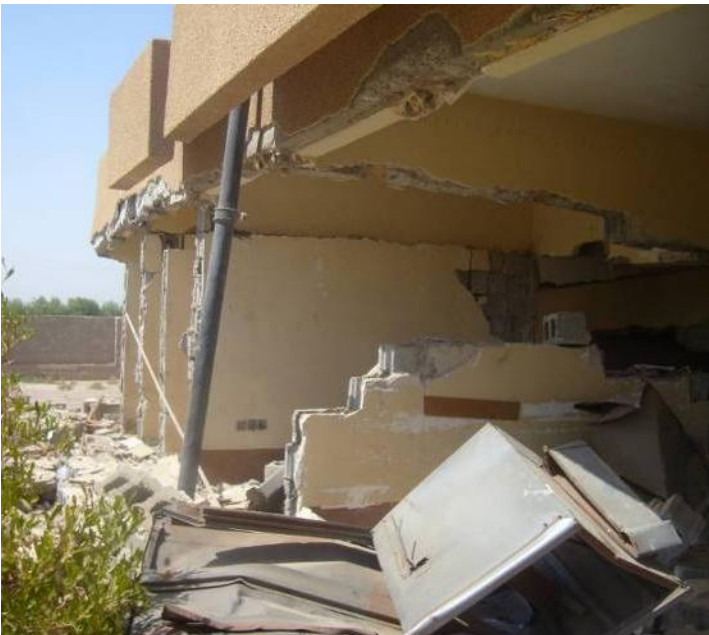
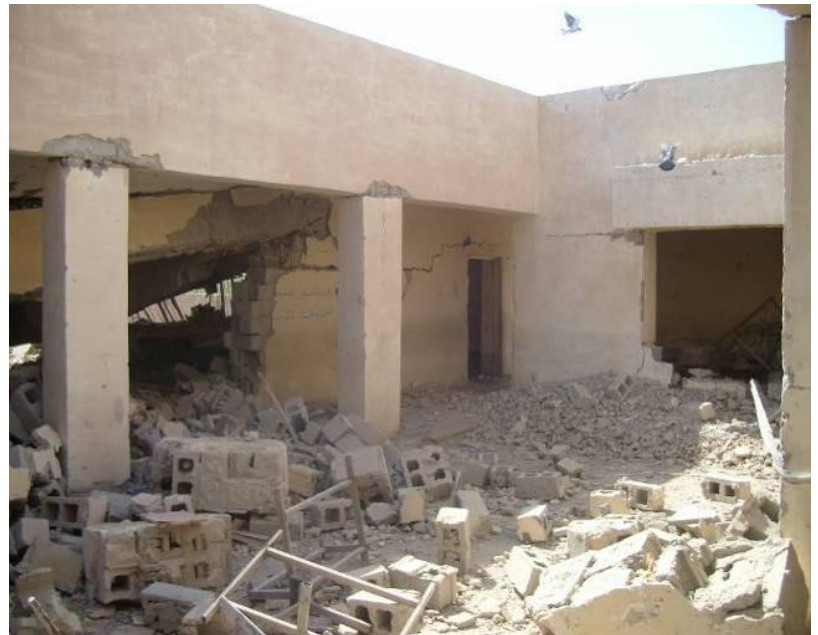
**Site Photos 2 and 3. Condition of the Al Shurhabil School prior to refurbishment
(Photos courtesy of MNF-I)**

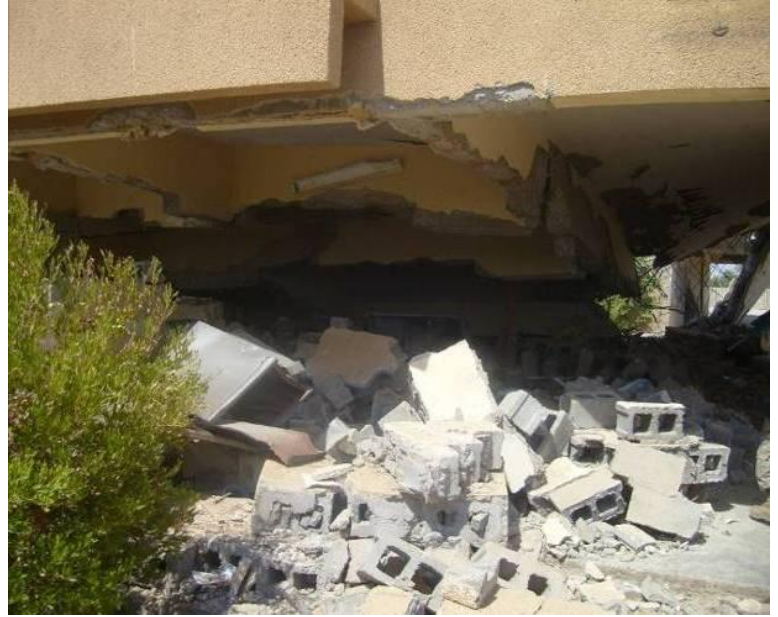
**Site Photos 4 and 5. Condition of the Al Shurhabil School prior to refurbishment
(Photos courtesy of MNF-I)**

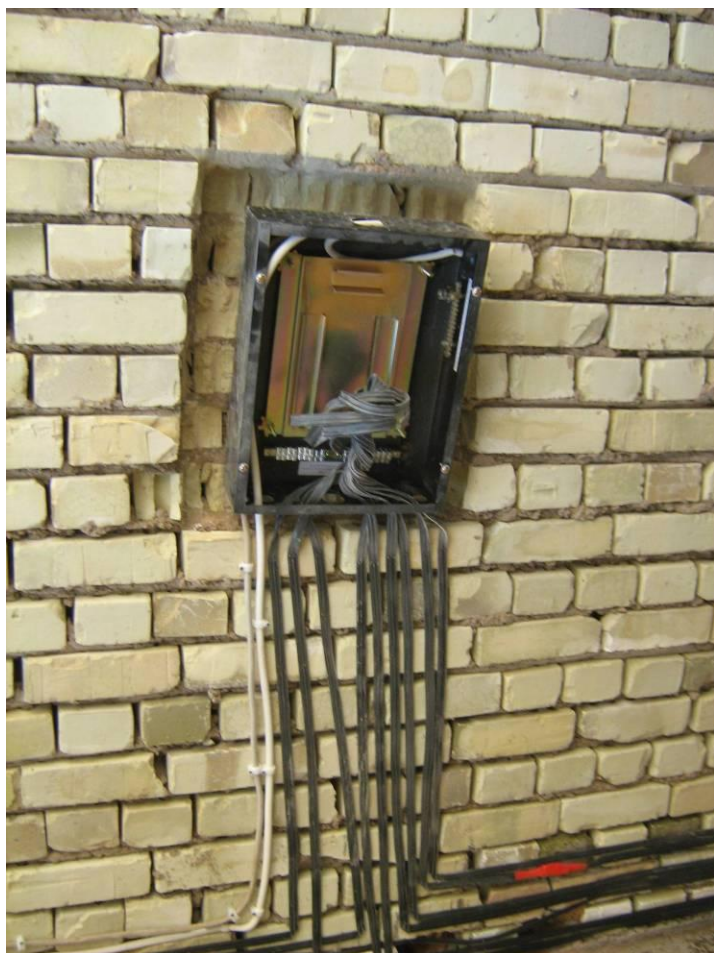
Site Photos 6 and 7 document the installation of electrical wiring within the main circuit board and general building construction.

Site Photo 6. Installation of electrical wiring
(Photo courtesy of MNF-I)

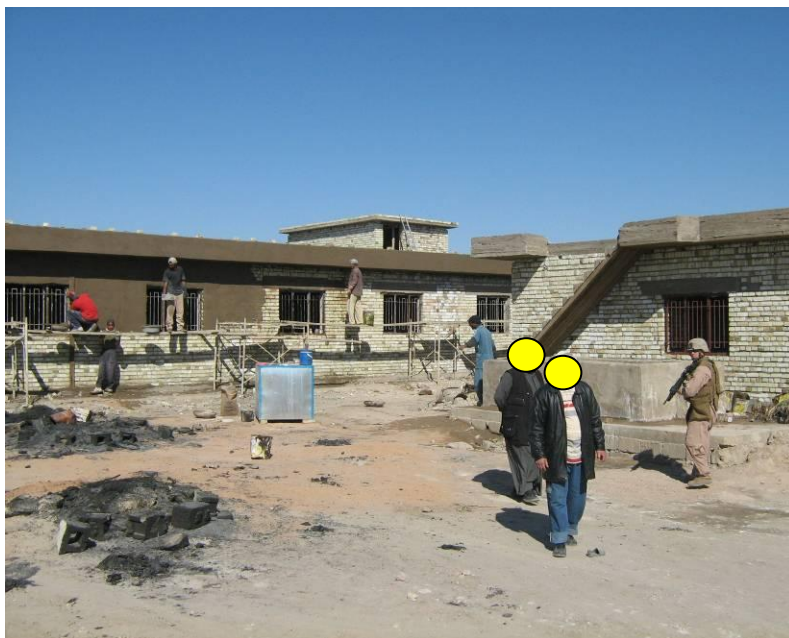
Site Photo 7. Ongoing general construction
(Photo courtesy of MNF-I)

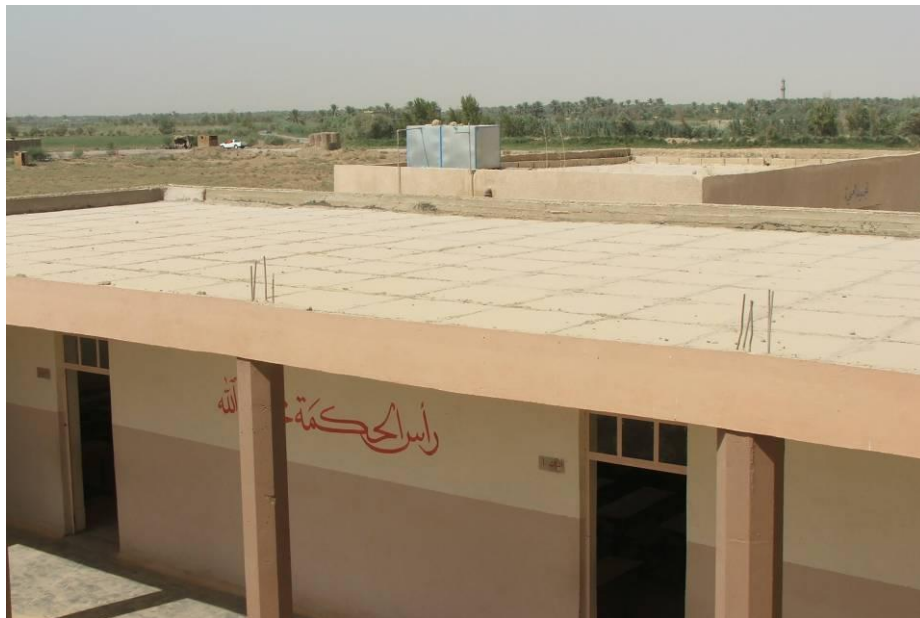
During the site visit, SIGIR observed the construction of the new classroom buildings. The roof tiles appeared to be in good condition throughout the expanse of the roof (Site Photo 8). There were drainage holes at the roof's edges, which will allow water to drain from the roof. The exterior and interior walls appeared to be adequately repaired/replaced (Site Photos 9 and 10). The majority of the interior tile and concrete floor work was good; however, there were areas of missing and broken tiles, as well as, uneven floors (Site Photo 11).

Site Photo 8. Condition of the roof tiles after renovation

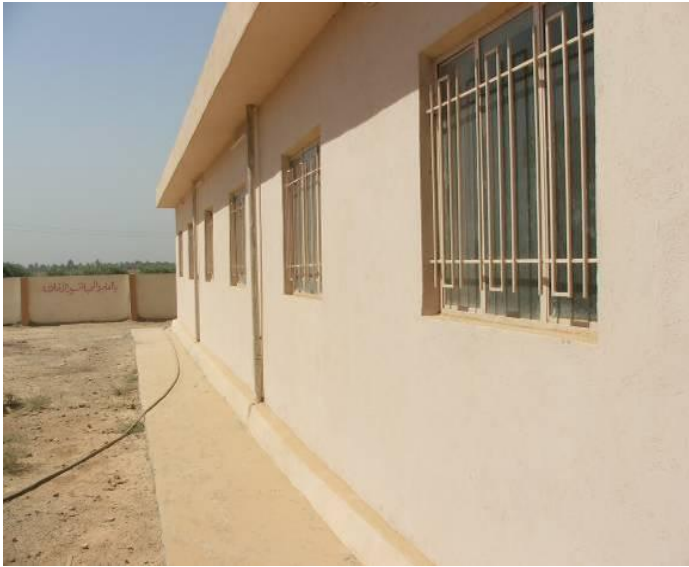
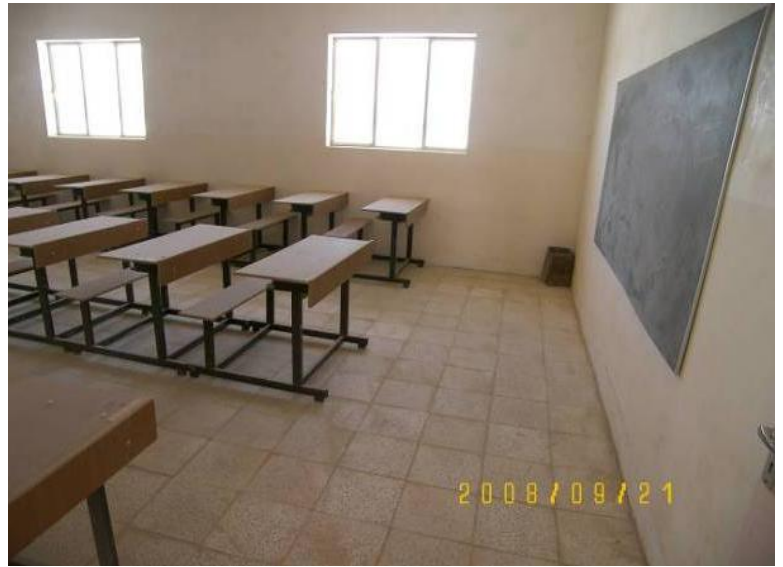
Site Photos 9 and 10. Adequately repaired exterior and interior school building walls

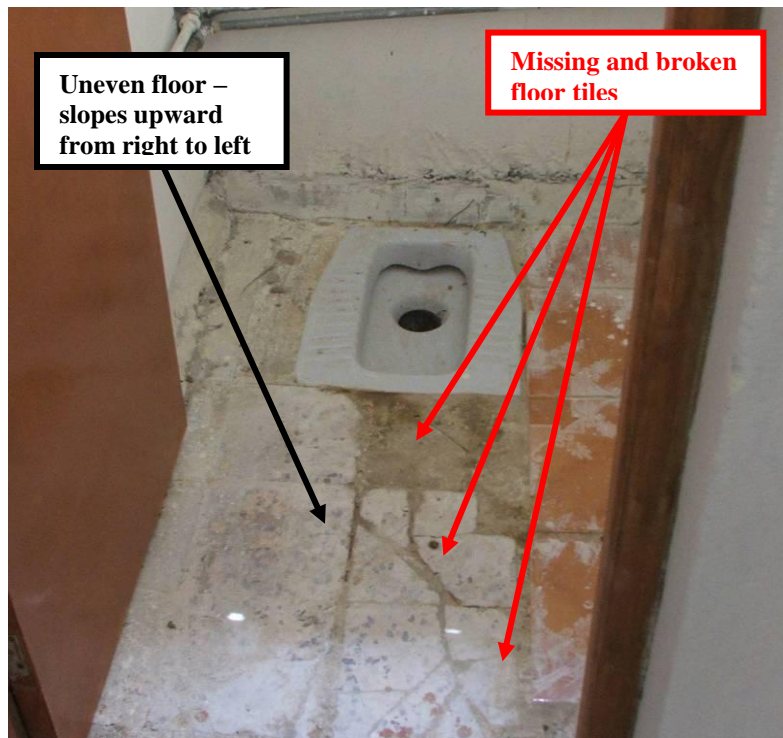
Site Photo 11. Example of uneven and broken floor tiles

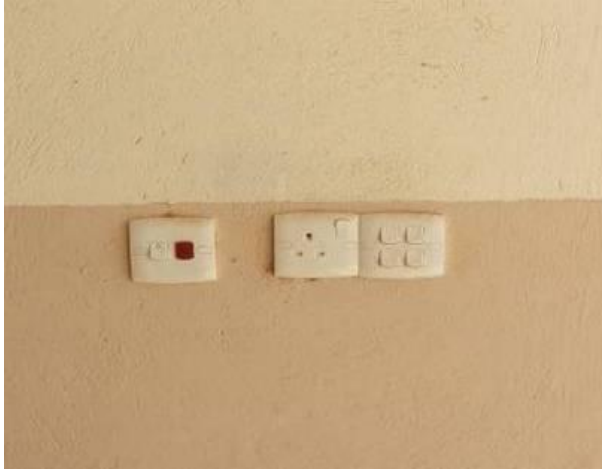
SIGIR verified the existence of the replaced wiring system by testing the newly installed switches, lighting fixtures, and ceiling fans (Site Photos 12 and 13). While going through the classrooms, SIGIR periodically tested the lights and ceiling fans and found them functioning properly. Although the mounts were constructed to hold A/C units, the actual A/C units were missing (Site Photo 14). It did not appear that the A/C units were ever installed. SIGIR asked the school's Headmaster about the A/C units; he responded

Site Photo 12. Installed light switches

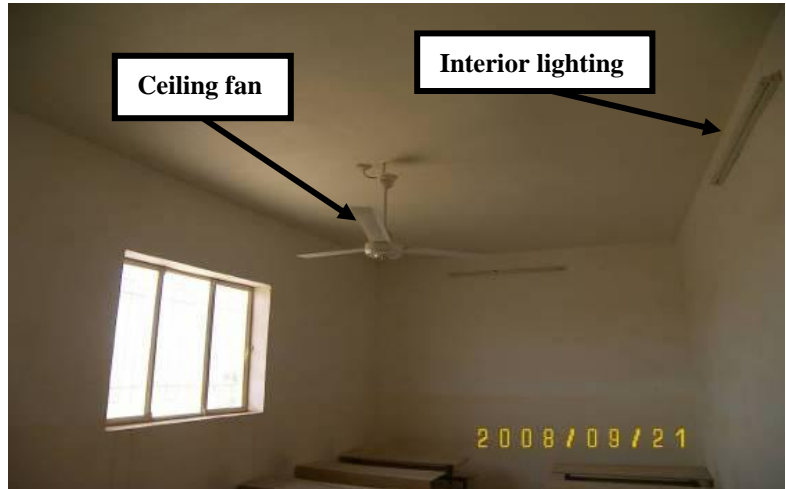
Site Photo 13. Newly installed ceiling fan and interior lighting

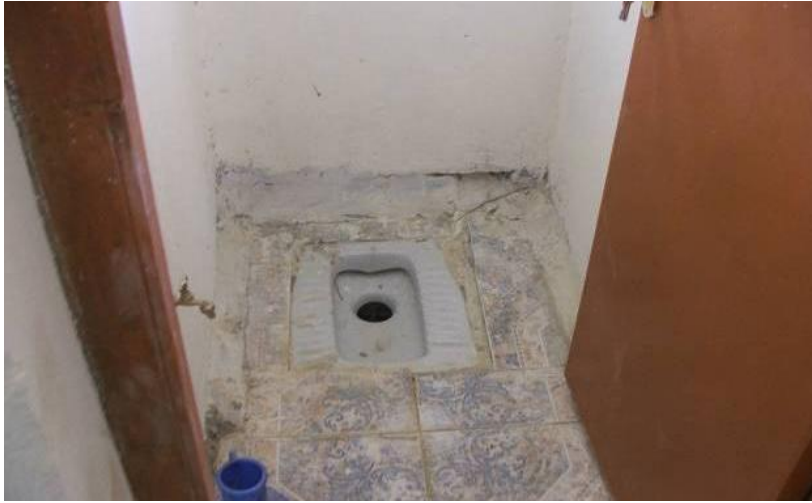
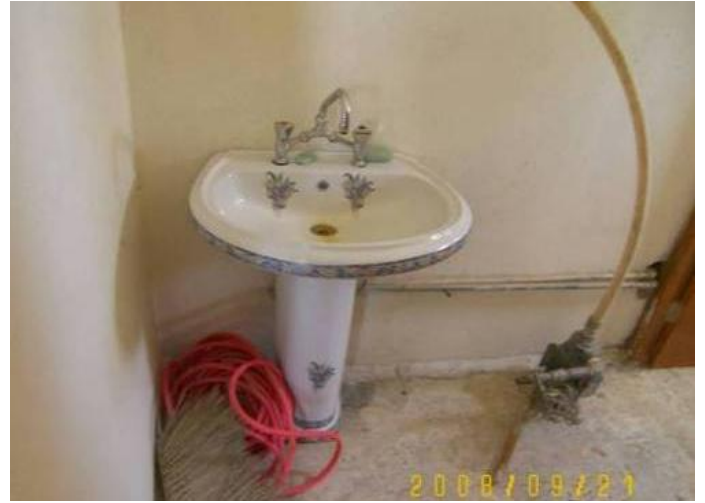
The school's bathroom facilities consisted of an inside bathroom for the teachers and administration staff and an outside bathroom for students. The inside bathroom consisted of four eastern-style toilets and a single sink (Site Photos 15 and 16). There were instances of crude construction techniques used in the inside bathroom, such as the tile installation securing of plumbing; however, the toilets and sink were functional and operational when tested.

Site Photos 15 and 16. Eastern-style toilet and sink in the inside bathroom facility

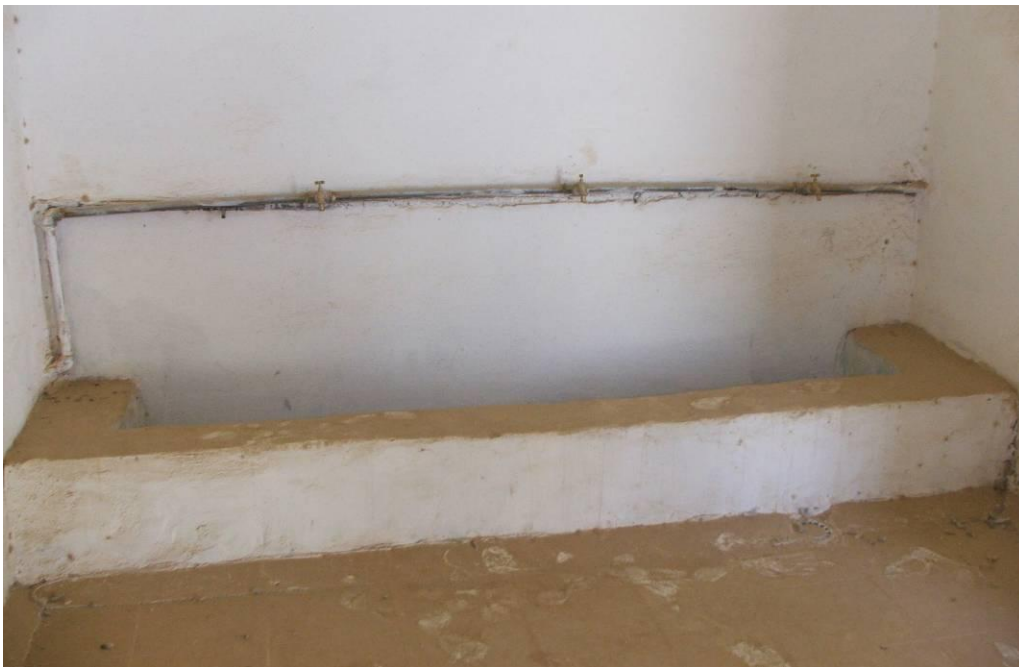
The outside bathroom facility consisted of eastern-style toilets, a sink, and a concrete bench to wash feet (Site Photo 17). This facility was more difficult to assess because of a significant amount of dirt throughout (Site Photo 18). Some of the toilets were clogged with debris from a lack of routine maintenance.

Site Photo 17. Feet washing bench within the students' outside bathroom facility

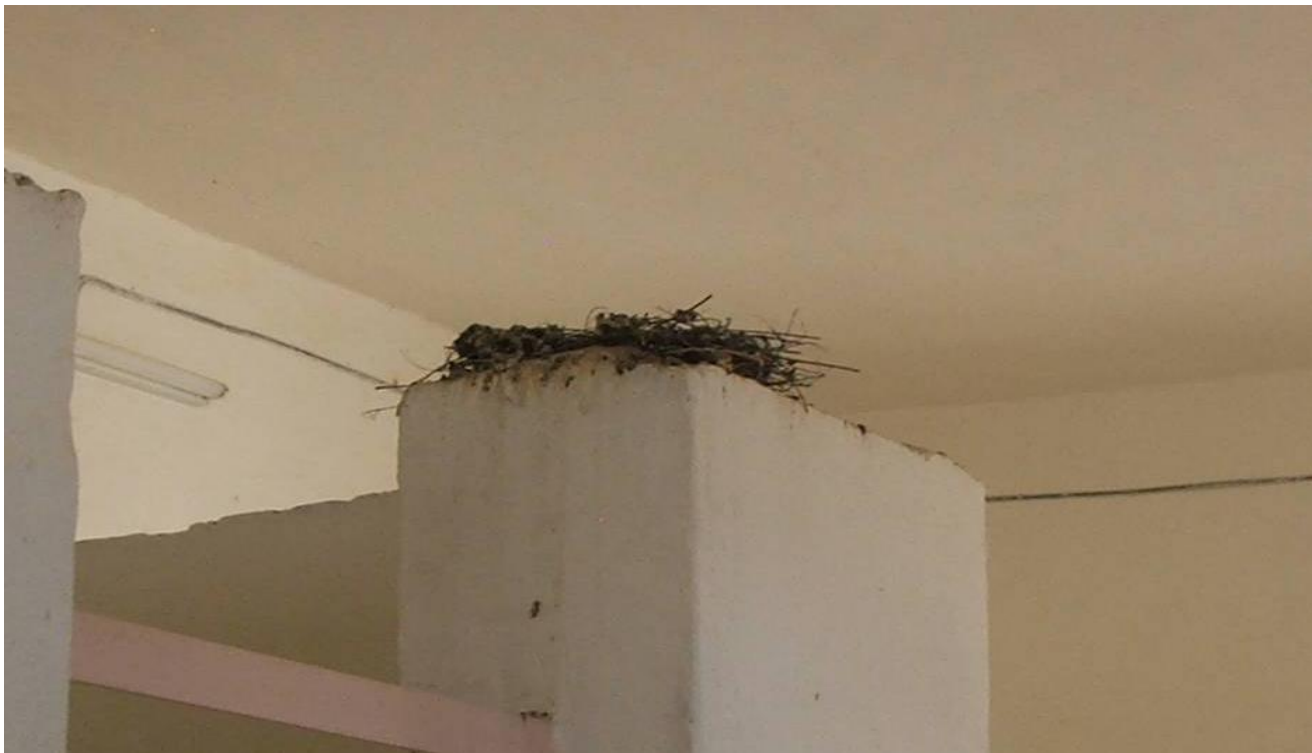
During the site visit, there were obvious signs that the school was not being properly maintained. For example, in the outside bathroom facility, a large bird’s nest (Site Photo 19) and a significant amount of dirt and dust were observed. According to the Headmaster, school was to begin approximately one week after the site visit. In order to be ready for the first day of school, a considerable amount of cleaning is required.

Site Photo 19. Further proof of no routine maintenance – a large bird’s nest within the students’ bathroom facility
